# Manhole Inspection Summary

Manhole # S61I\_\_011MH

Insp Date: **7/8/08 9:01 AM**

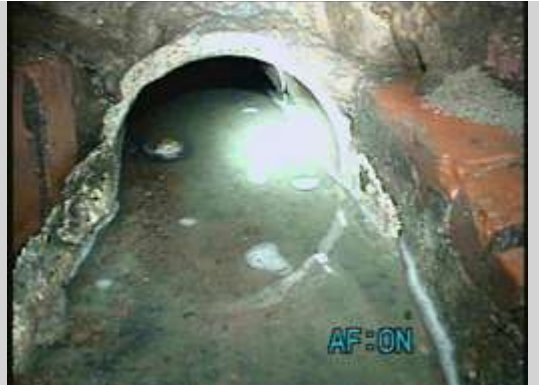
12 O'Clock Outflow

8 in. Circular Gravity Sewer  
Pipe Out @ 12 OClock

Infiltration: None Pipe Seal Cond: Unknown

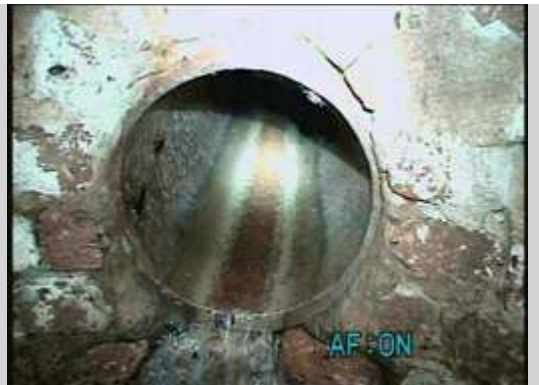
7 O'Clock Inflow

8 in. Circular Gravity Sewer  
Pipe In @ 7 OClock

Drop In @ 7 OClock

Infiltration: None Pipe Seal Cond: Unknown

Drop Condition: Open
